MVCC 1944 M29 Weasel Restoration Diary

Ord Serial # 8325; MFRS Serial # 8325; Gross Weight 5970; Max Payload 1200
Max Speed 32; Gasoline Octaine 72 minimum
Hull markings; 3BCT 3 HQ 5 and 68GP2IE C52

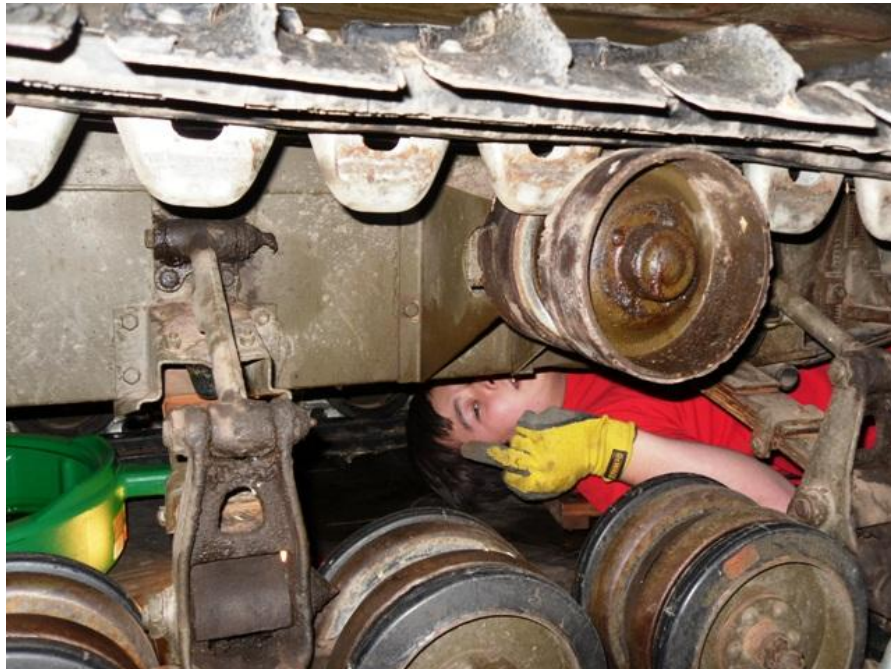
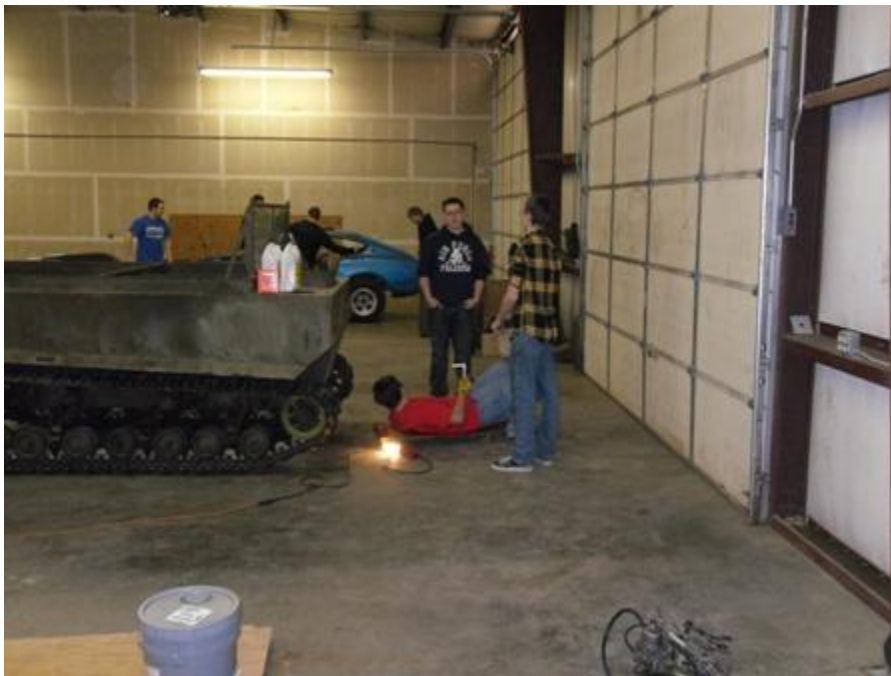
I attached a picture of Jared who was getting set to drain the engine oil. As you can see, he has learned to act like a mechanic and not a scout in short order. I guess someone there is number one!!

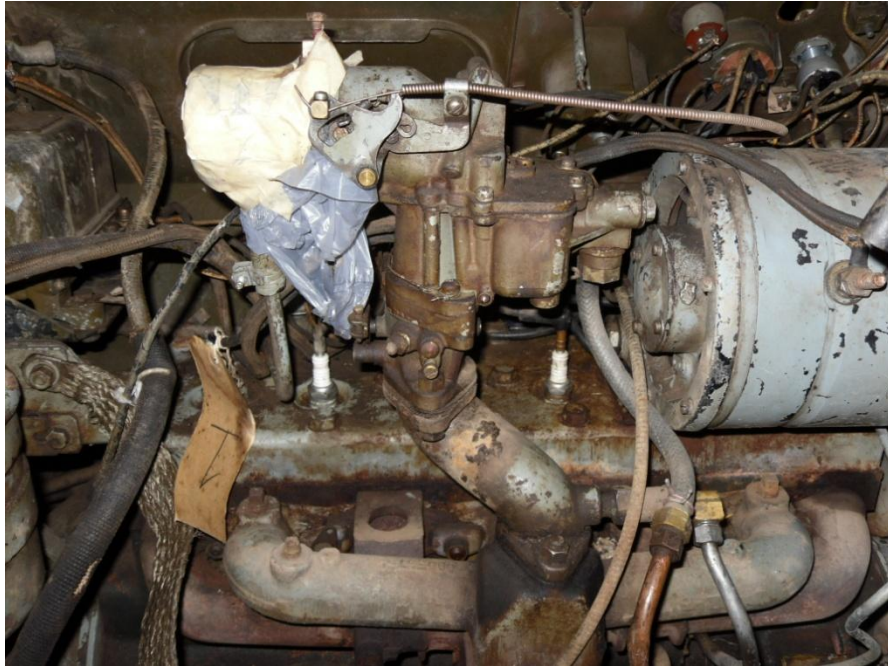
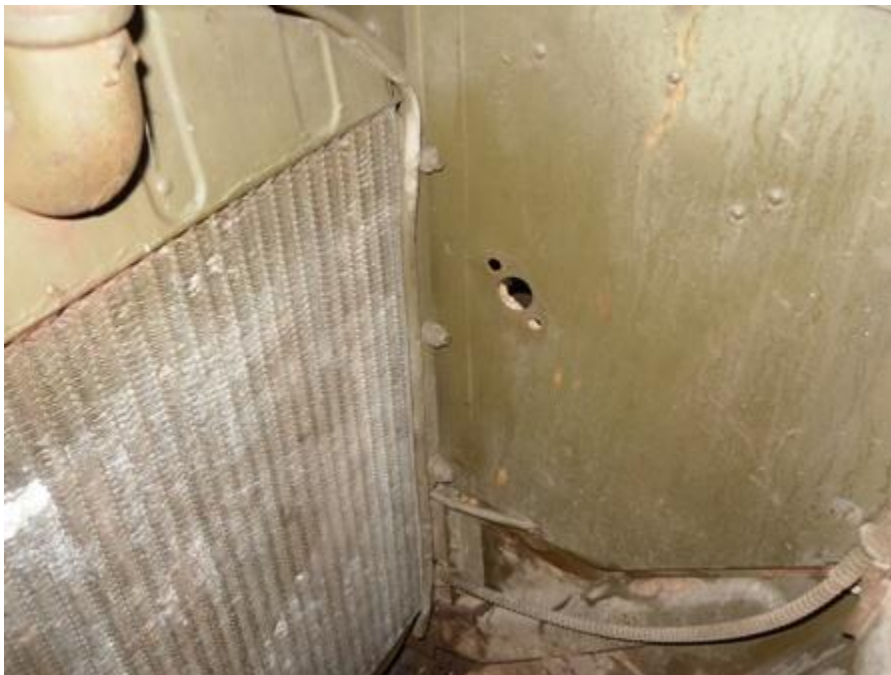
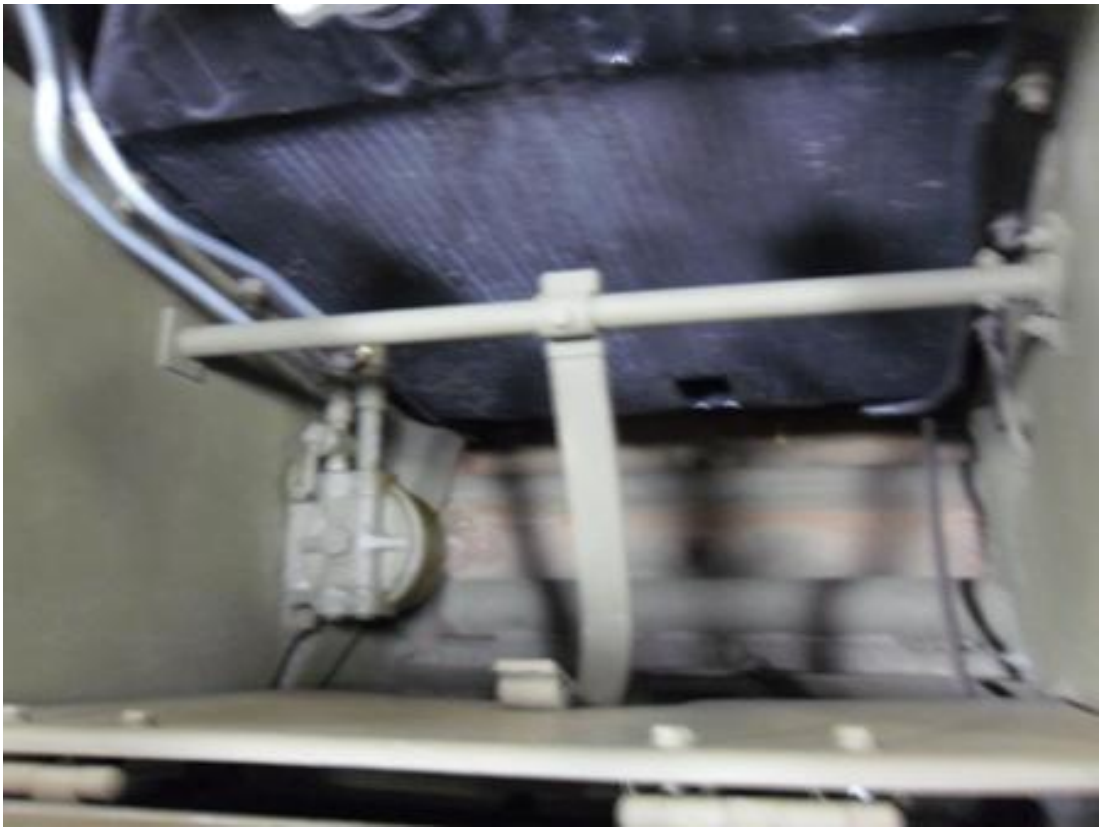
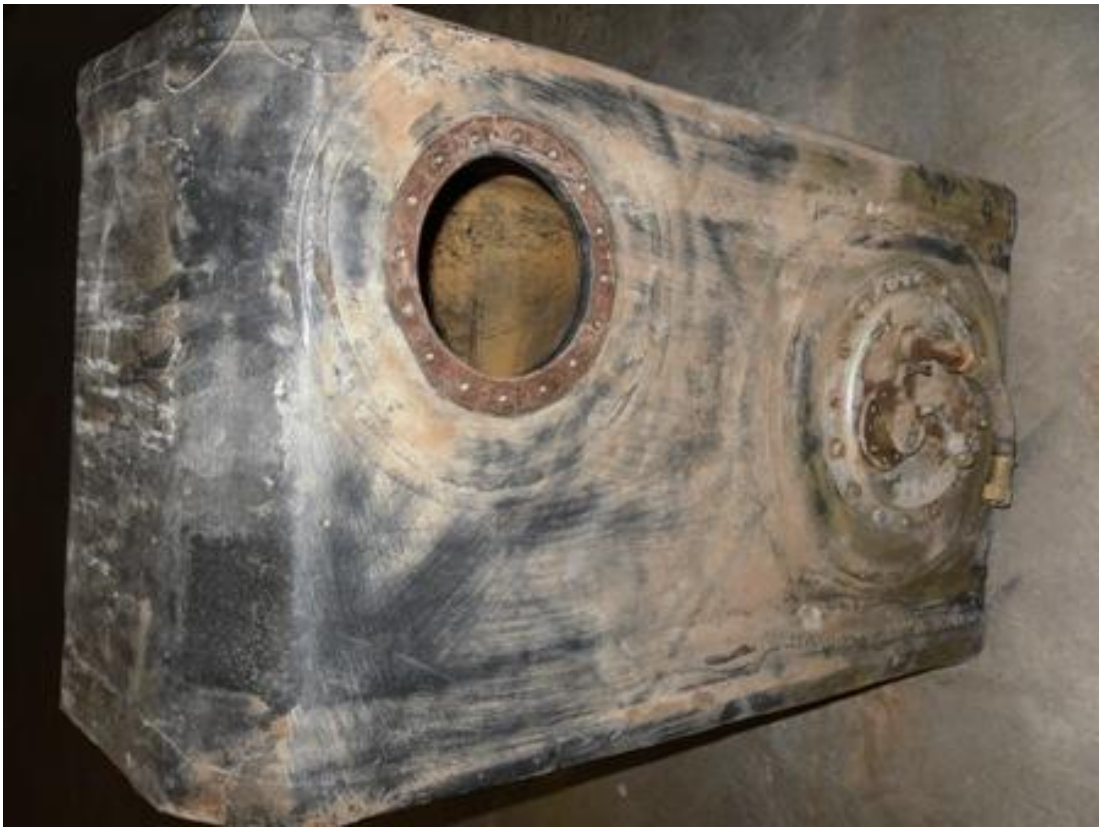
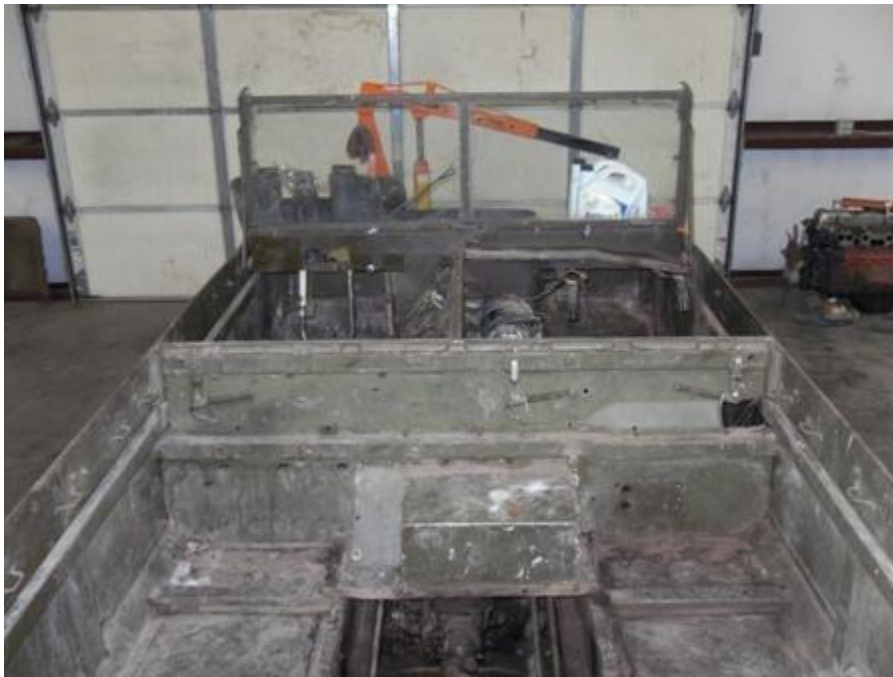
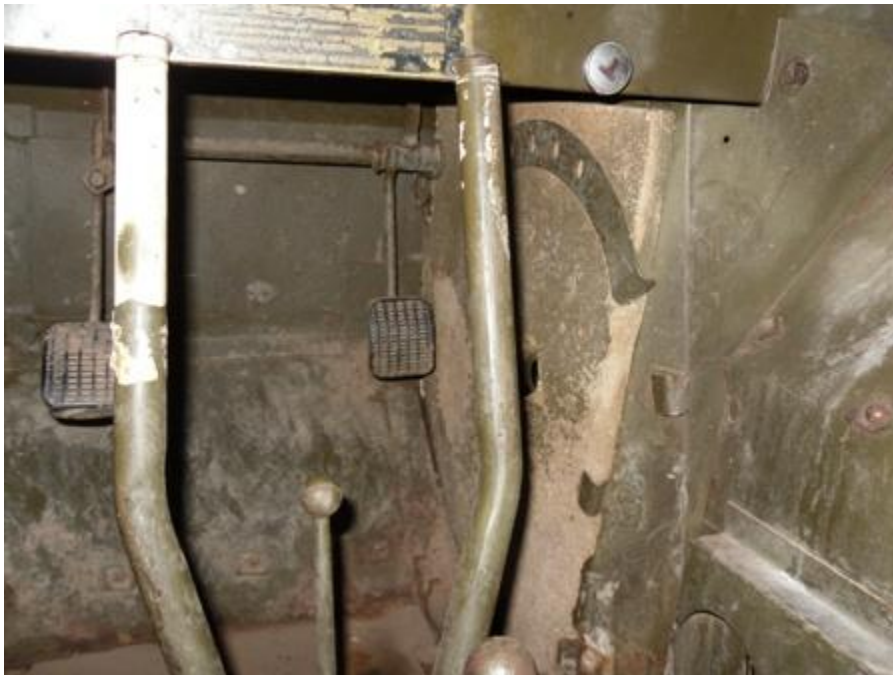
3-13-11. The fuel tank is a rubber one. I am learning that these were added post WWII to replace the metal tanks which rusted out. The view of the radiator shows it's missing the linkage for the big door to the radiator. This was used to adjust the air flow. The steering controls picture shows the hole in the wall where the control for the radiator door should be. The side of the engine shows how complete it is. Have not tried to fire it up yet. Waiting for a few details first. The last picture shows the cleaned out tub.

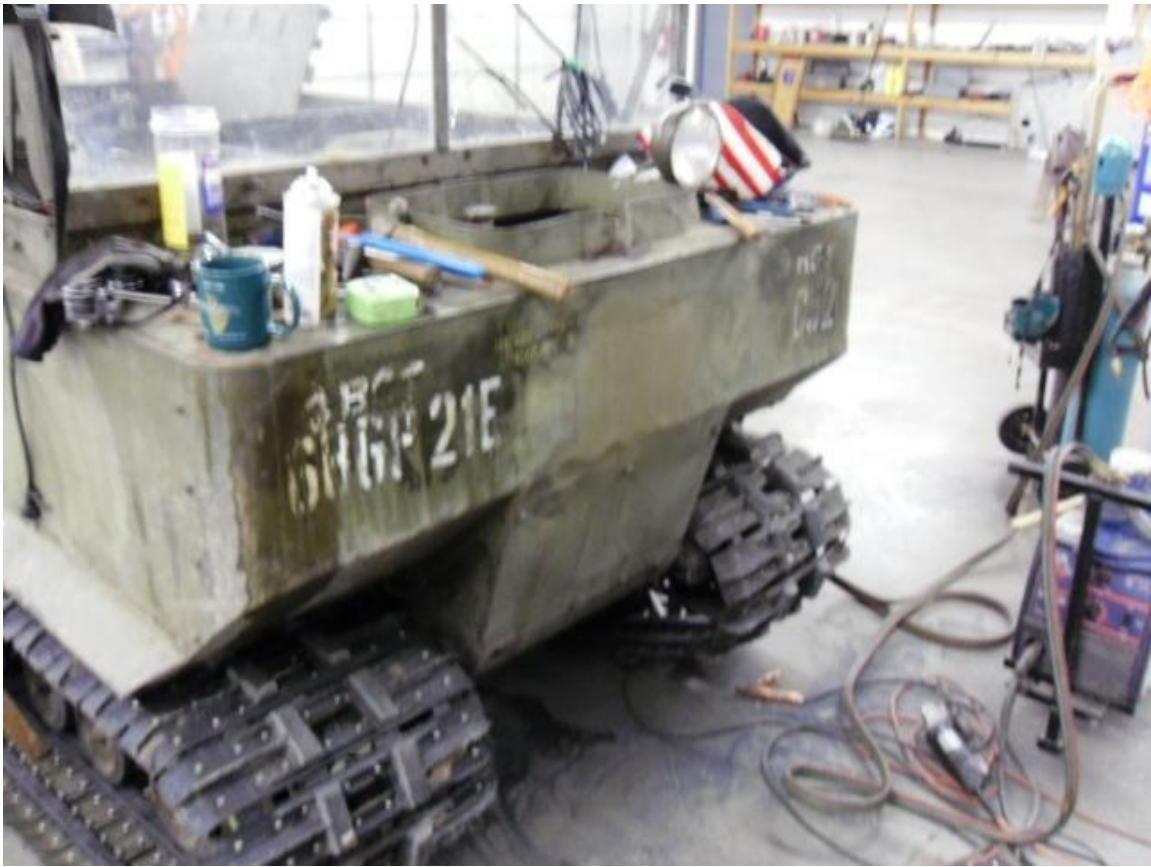
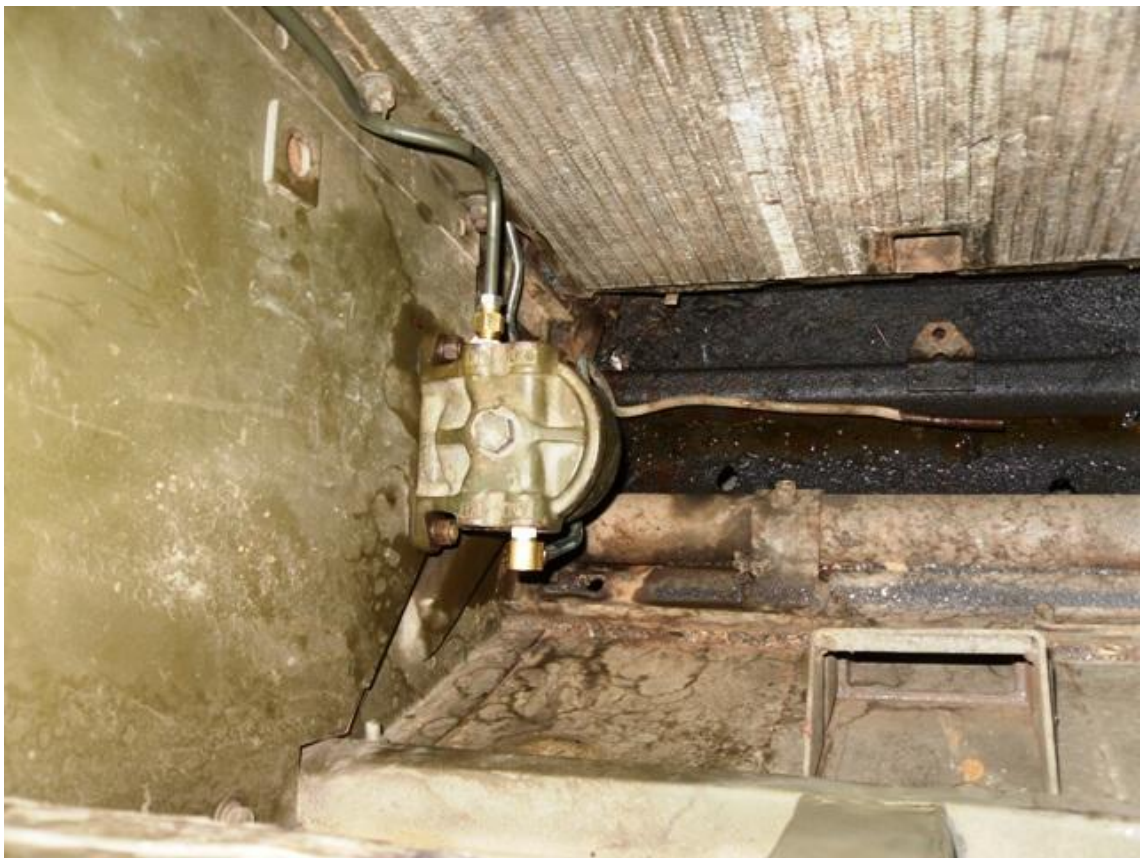
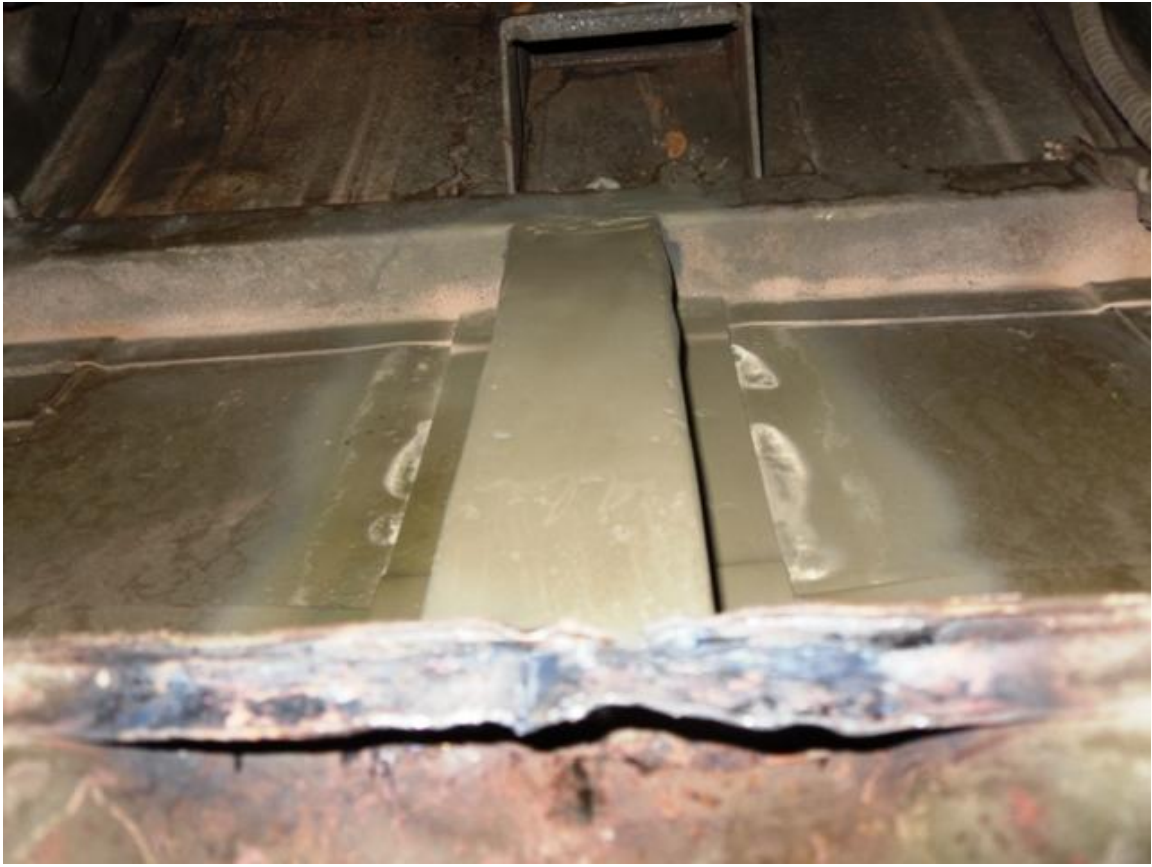
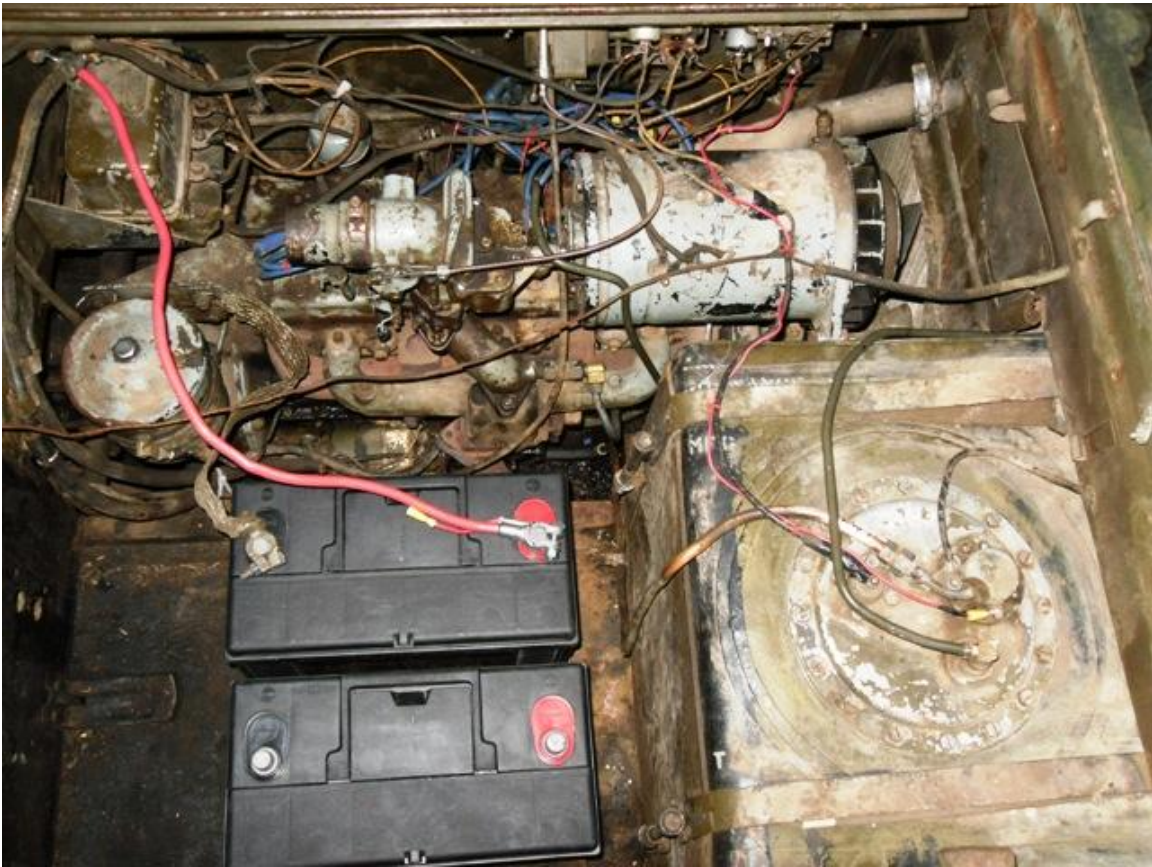
4-24-11 Great progress has been made on the weasel. Many thanks to Ray for his many hours of help. Fuel system redone so we can use the rubber tank and in tank pump. Carb cleaned out. Had some dirt in the float valve that cause over fueling. Used a gasket kit from Russ. That fit perfect. New steel fuel lines made so we can use the original fuel filter. Carb mounts were loose allowing air to suck past gasket. Dan Emick talked to his battery guy, Walters Auto Specialties, and got 2 nice batteries donated to the project. Value of \$267.90! If you need a battery or other auto stuff, contact Walters at 303-783-3818 and in Colo. Springs, call 719-391-1288. Be sure to spread the word to support this outfit! The new batteries start the weasel real fast. She now runs perfect! Smooth idle and tons of power! I cut out the Bubba tow ring in the bow of the weasel and replaced the original skin. The previous owners had punched a couple of holes in the body and a hat channel to attach a tow chain. Under the 1/4" plate they welded over the damage, it was ugly. She is all repaired there now and looks factory. With all of that done, the club needs to decide what the next step is. She could use some back seats. Dan thought that whoever donates enough for a back seat could have their name stenciled on the seat back. She also needs some correct controls on the dash, and the radiator flap repaired with proper controls. Since she runs so well, we don't think the mechanicals need any repair. She could use a correct wire harness for the bubba electrical work done. She also needs the panel between the engine and the fuel/ battery area. And she needs the tube between the carb and the air cleaner. Dan was talking about a BBQ at my shop on Saturday the 7th as a fund raiser for this project. He has set up his field kitchen in my yard. More to come on this. A few pictures follow.
